ENGINEERING FORENSICS EXPERTS LLC

ENGINEERING EXAMINATION and ANALYSIS
REPORT #1

File No: 4874-0701

Date of Incident: June 19, 2014
Location of Incident: 15723 E. Appleby Road, Gilbert, AZ 85298
MCSO Case: IR 14-014274

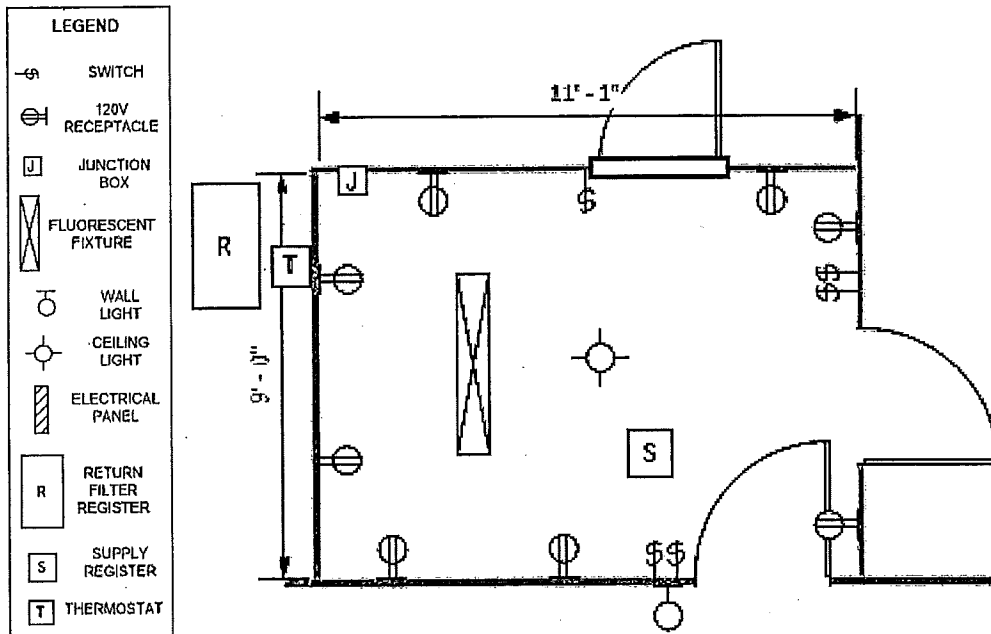
Figure 3. Plan view of "dog room" showing electrical and mechanical fixtures and devices. Not to scale. Red rectangle indicates sealed doorway into girl's bedroom.

Figure 3 shows an enlarged Plan View of the room where the dogs had been placed with the electrical and mechanical components of interest shown. For the purposes of this report, we will refer to this as the "dog room". The door to the north that led into the girl's bedroom had been completely and permanently sealed with caulking such that no air could pass, which is shown by a red rectangle in Figure 3. Note that there is one HVAC (Heating, Ventilation, and Air Conditioning) supply register in the ceiling in the dog room and that the return register and filter as well as the thermostat are in the closet of the girl's room to the west.

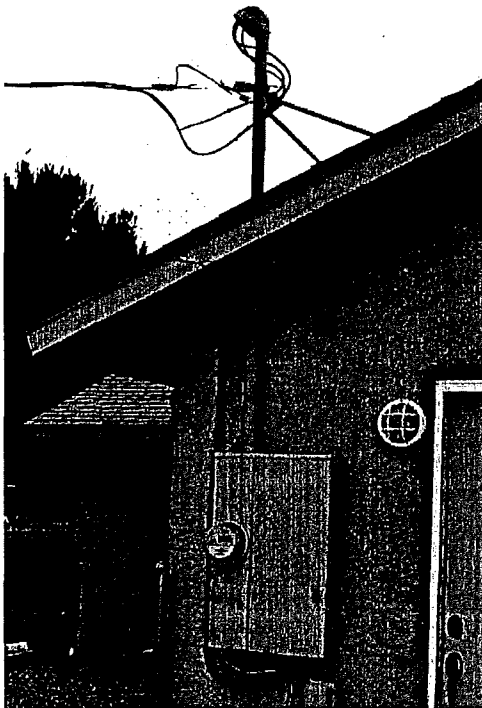
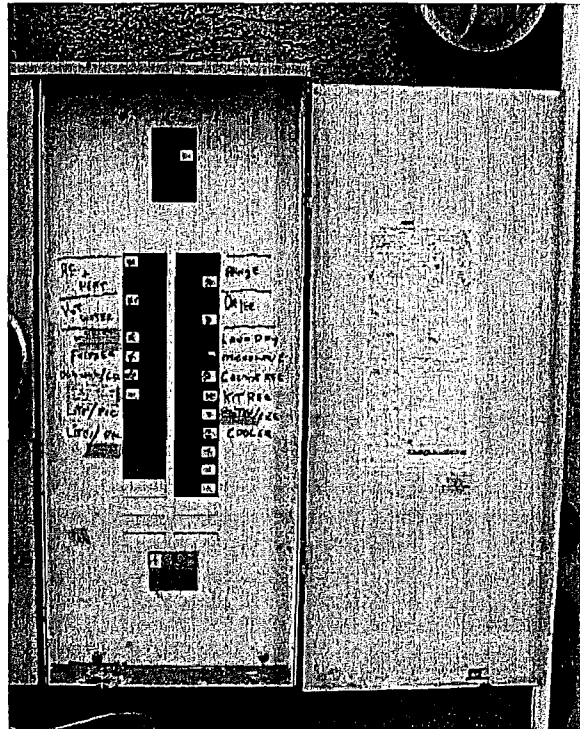
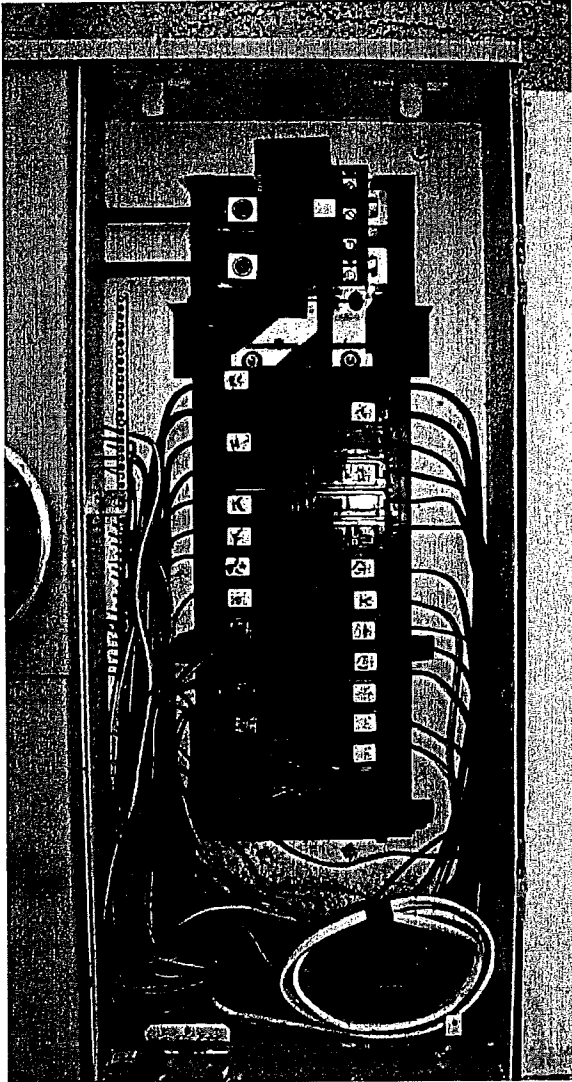
Figures 4-6 show the electrical service panel on the north end of the west exterior wall. The electrical service panel was a typical modern combination metering and circuit breaker panel rated at 240/120 volts, 200 amps, with a 200 amp main circuit breaker. The main service panel was supplied via an SRP overhead lateral from a pole mounted transformer. There was nothing remarkable about the physical condition of the service panel. The panel contained a number of branch circuit breakers that are there to control and protect the branch circuits that extend into the house wiring systems. Apparently some circuits and breakers had been moved as the labeling was not complete nor correct. Otherwise, no remarkable deficiencies in code or workmanship were found.

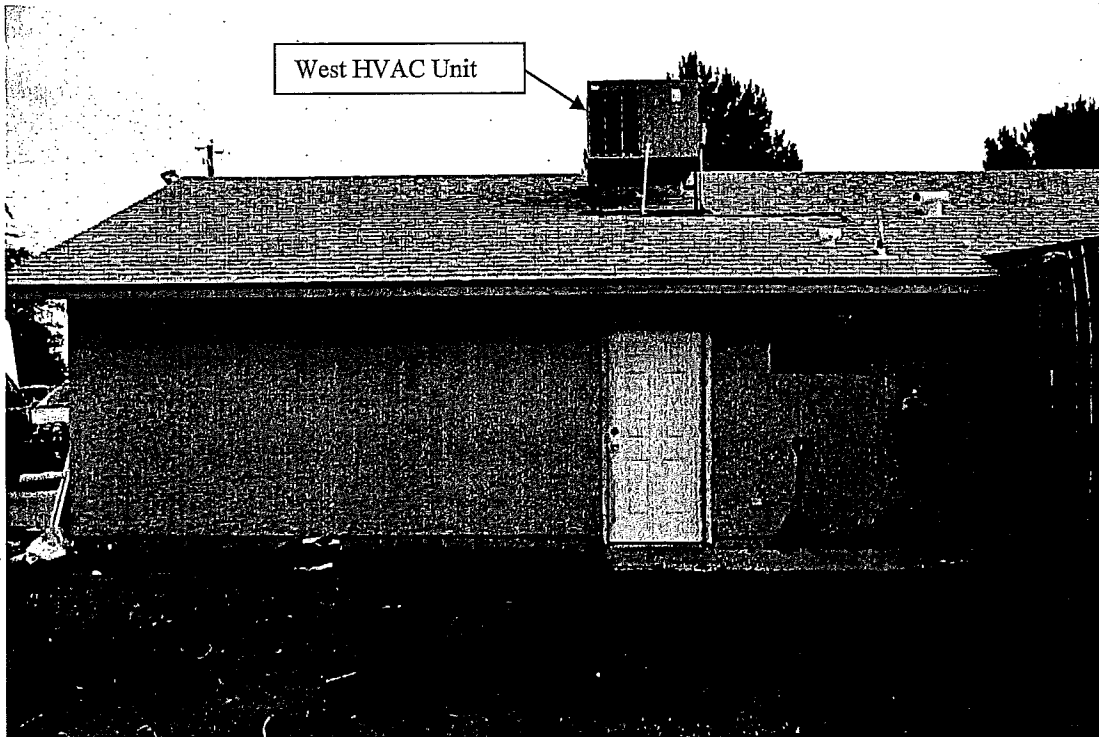
Figure 7 shows the south exterior door entering into the dog room and also shows the HVAC system that serves the west portion of the home. For purposes of this report, we will refer to this as the “west HVAC” unit. Figures 8-11 show the interior walls of the dog room, which was measured to be 9 feet by 12 feet and the ceiling was 8 feet, 3 inches from finish floor. The passage door shown in Figure 9 that led to the girl’s bedroom had been sealed completely with caulk so no air could pass through at all. The passage door into the laundry room and the exit door to the south yard shown in Figure 10 both had sweeps and weather stripping such that the room was actually fairly tightly sealed.

Figure 7. South entrance into room where dogs were found. Note west HVAC unit on roof above door.

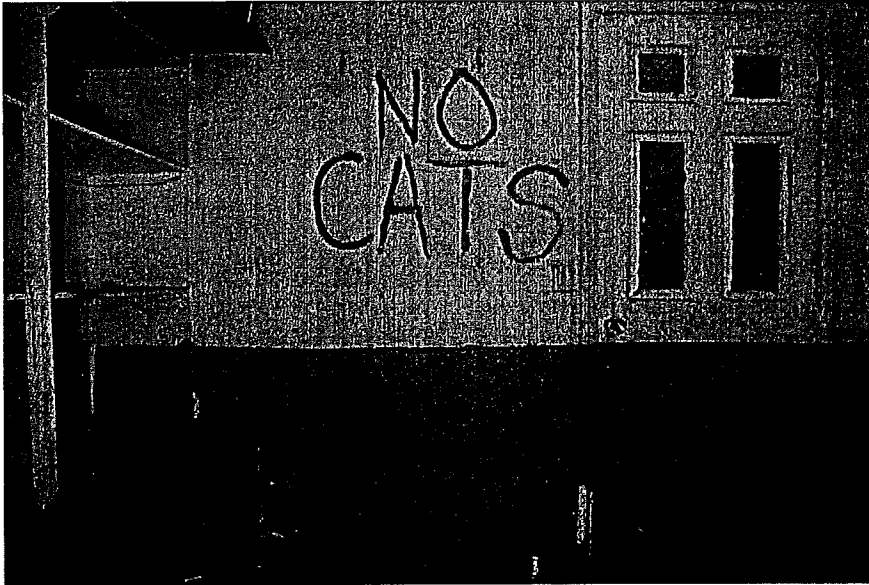
Figure 9. West end of north wall of dog room. Repaired romex at lower left.

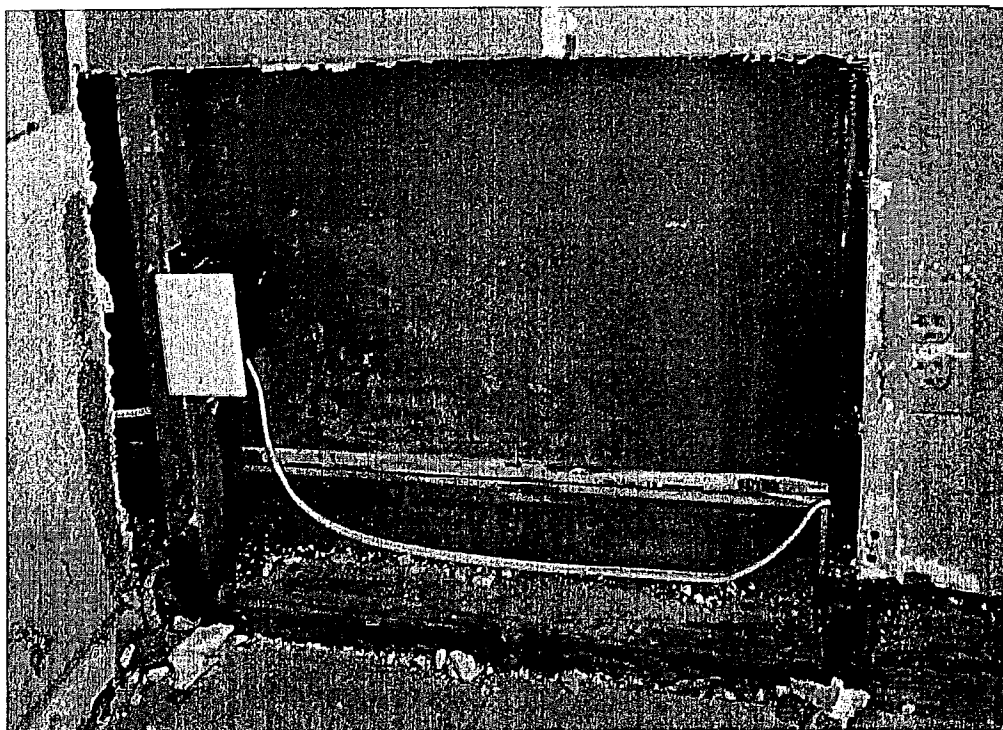
Figure 12. Repaired romex in west end of north dog room wall.

Figure 12 shows the location where the romex cable had reportedly been chewed on by a dog. It was apparent that this segment of cable had been replaced since the incident. A "new" segment of 14/2 romex had been extended from the receptacle in the wall to the east to a plastic junction box that had been installed to make a legal splice in. NEC (National Electrical Code) requires that all splices in any wiring must be accessible from the living space so this junction box was required to make such a splice. As shown in Figure 13, the splice was made using typical "wire nut" splice connectors that are suitable for the purpose.

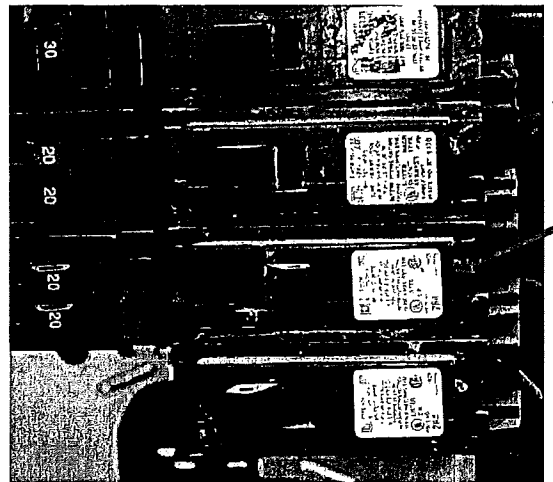
This circuit was then traced to the source using a toner and it was determined and verified that the circuit was serviced via the 15 amp single pole circuit breaker in the #24 position in the panel as shown in Figure 14. This circuit was limited to receptacles and lighting in the southwest corner of the home.

Figure 14. Breaker 24 serves repaired circuit.

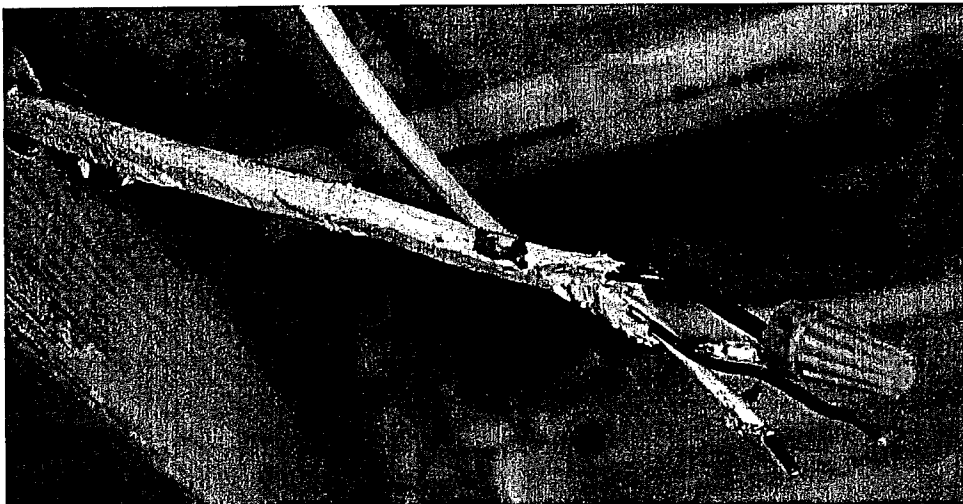
Figure 15 shows the remaining end of the original circuit romex at that location, which is a 14/2 cable. It is apparent that the wall was open such that the dog was able to access this cable as evidenced by the blue paint on the external sheathing and the blue paint on the interior backside of the drywall on the opposite side of that wall space. Figure 16 shows that this original segment extended around the corner into the west wall where it was terminated at another duplex receptacle which is a typical residential installation.

Figure 15. Remaining portion of original romex into area of damage.

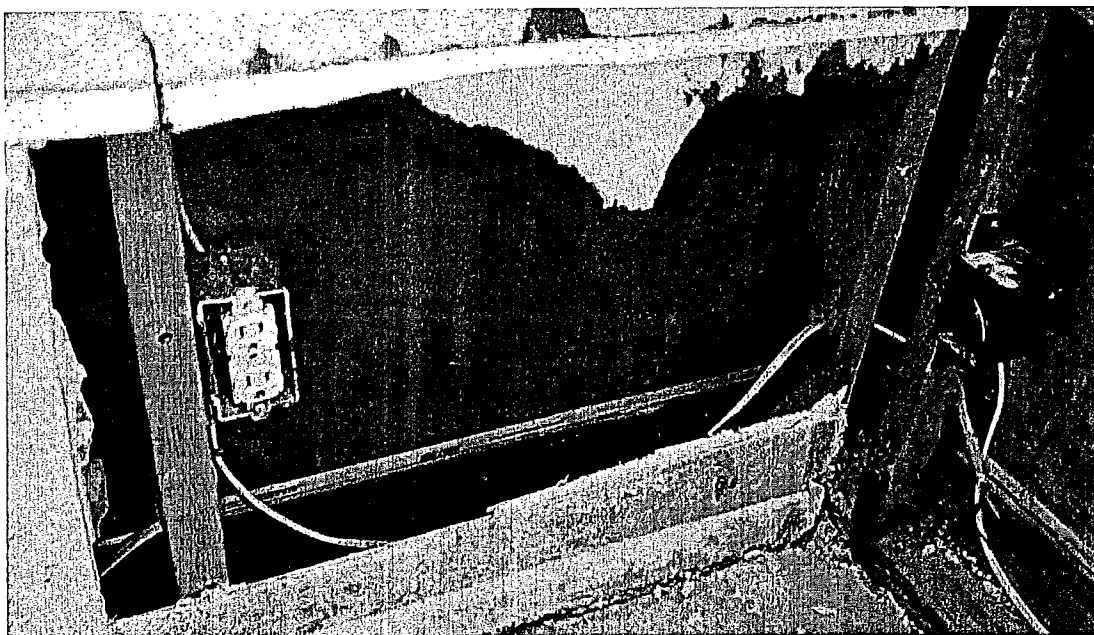
Figure 16. North end of west wall opened to show routing and termination of remaining portion of damaged romex segment.

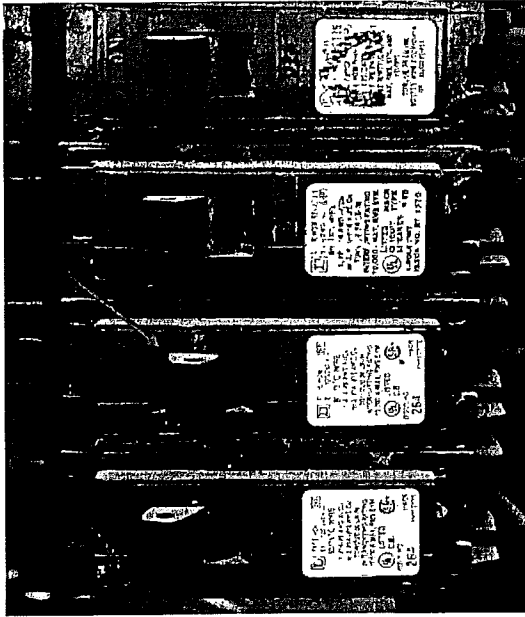
- ANSI/NEMA AB4, Article 5.5: Inverse Time Overcurrent Trip Test: This test is conducted by placing a load of 200 to 300% of the rated current on the breaker and would in this case simulate the current that could be expected if a dog chewed on the cable and caused a short circuit that traveled through the saliva and flesh of the dog's mouth. For this test, a load of about 32 amps was placed on the circuit of the 15 amp breaker as shown in Figure 17. Within less than 20 seconds, the 15 amp circuit breaker tripped (Figure 18) and the current flow ceased. The 200 amp main circuit breaker was unaffected (Figure 19) and the HVAC units continued to operate.

Figure 18. Breaker 24 tripped during tests.

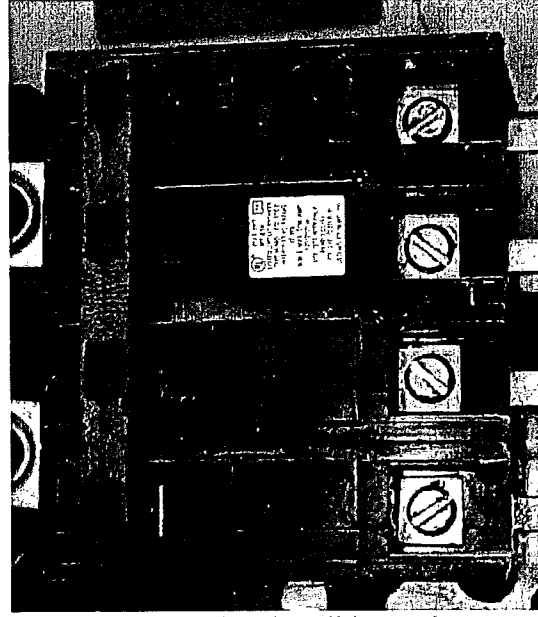
Figure 19. Main breaker did not trip.

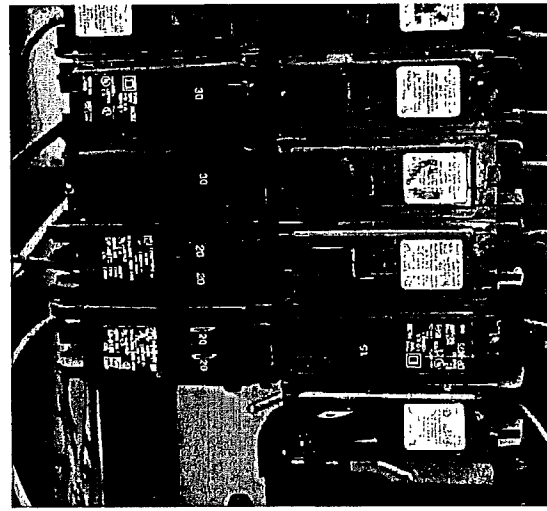
Figure 20. Bus stab at space 24.

Figure 21. New circuit breaker installed at 24.

The 15 amp circuit breaker was then removed from space 24 and retained as evidence. Figure 20 shows the bus stab where the circuit breaker had been installed into the panel and the factory grease is still present, indicative of no heating or other anomaly of the circuit breaker. A new 15 amp single pole breaker was installed and terminated to the circuit as shown in Figure 21 so power could be restored to the circuit.

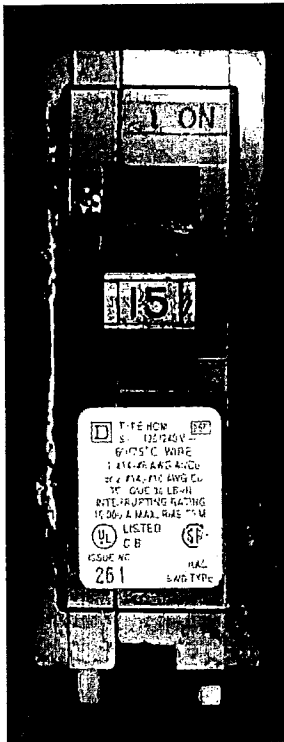
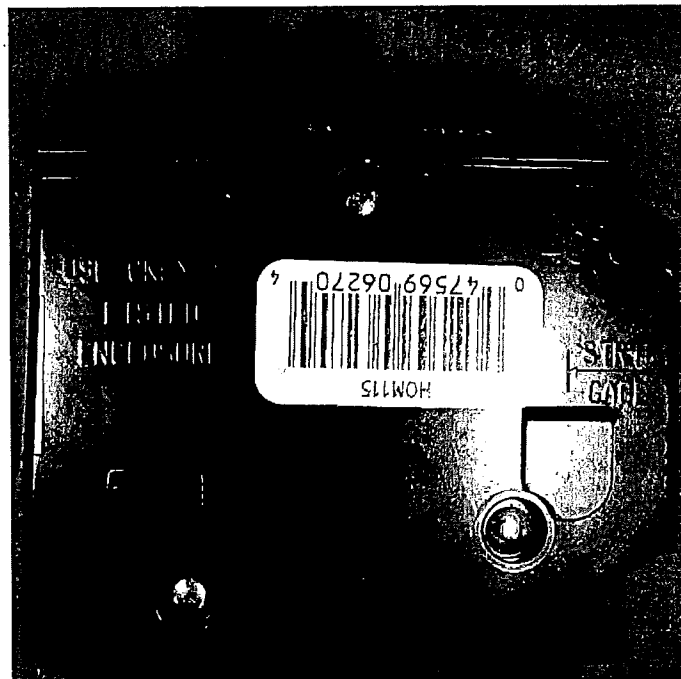
The 15 amp single pole circuit breaker from space 24 was then examined and there was nothing remarkable about the circuit breaker (Figures 22-23).

Figures 22-23. Front and side views of subject circuit breaker from space 24 in electrical service panel.

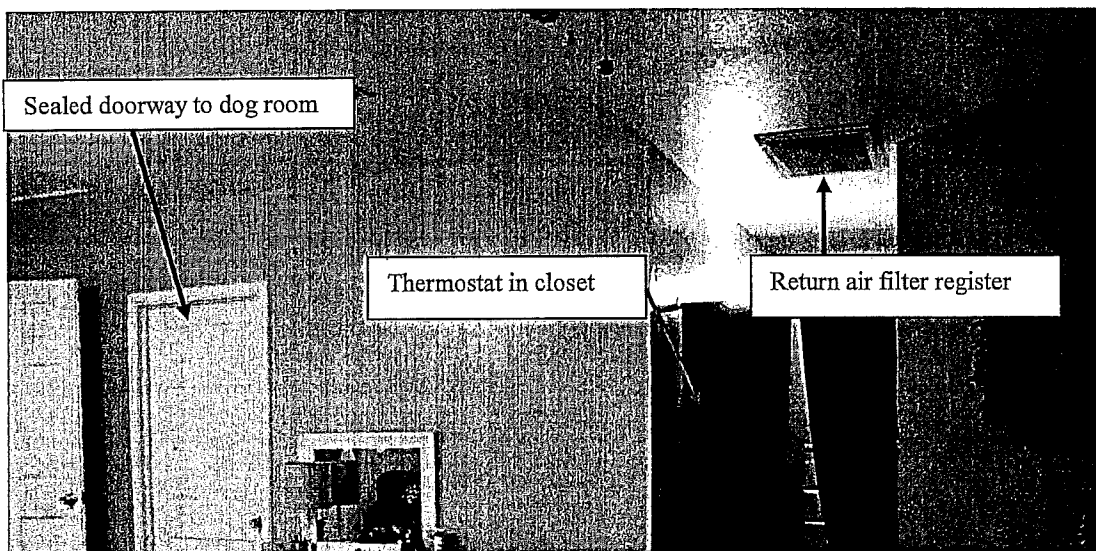
The thermostat and the only return air register for the west HVAC were found in the closet of the girl's bedroom as shown in the Plan View of Figures 2 and 3 and in the Photos of Figures 27-28. Figure 28 shows filter in filter grill. It is extremely bowed up because air is not flowing easily through air filter. Figure 29 shows the return air filter on the ground and the filter was found to be extremely dirty.

Figure 27. View of sealed dog room passage door and return air filter register from girl's room looking south.

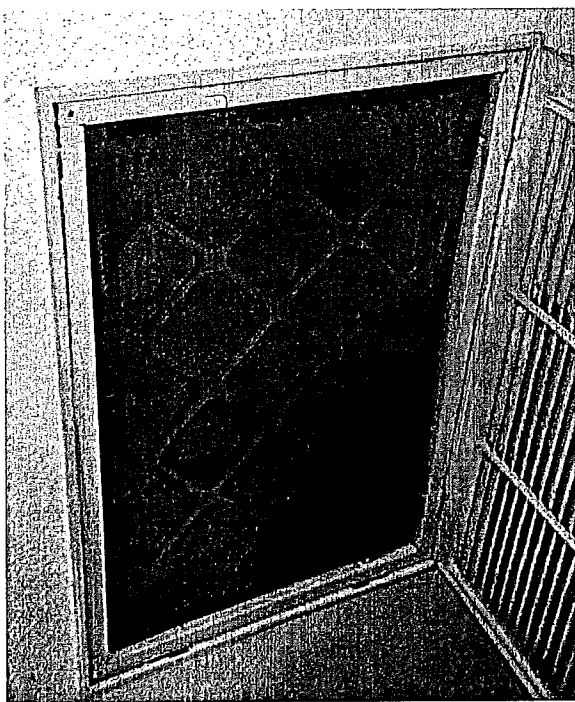
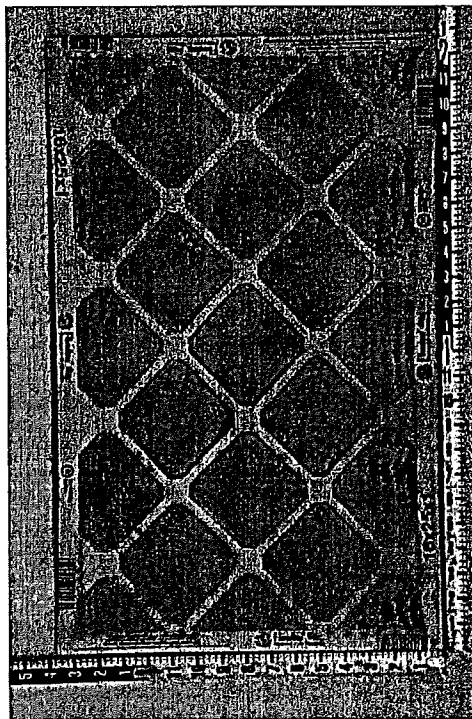
Figures 28-29. Return air filter in register over closet in girl's room and on ground after removal.

A plugged return filter will cause a number of problems with an HVAC unit besides poor airflow and poor cooling, including the likely condition of freezing up the indoor coil (evaporator coil) which will block all the airflow and render the unit completely ineffective.

The first remedy to the problem could be to have two 8" supply ducts to the dog room or one 10" run. You would need an air return in this room or an exhaust fan. A 2 ton unit cannot handle the heat load or CFMs for these two rooms. It would need to have at least a 2 ½ ton unit. The thermostat should be in the dog room as this has the greatest heat load. The second remedy would be to install a 1 ton ductless unit in the dog room and you would still need to have an exhaust fan in the room to replenish the oxygen. No matter which remedy is used it is imperative to keep the air filters clean.

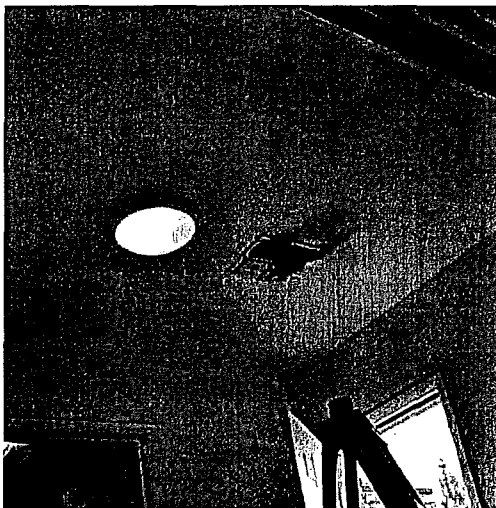
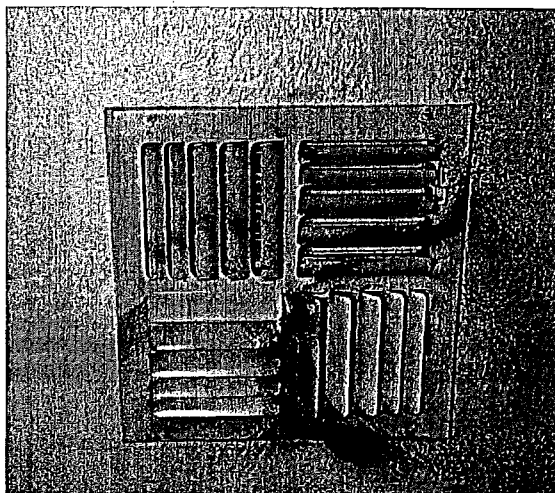
Figures 27-28. Single 10" by 10" supply register in dog room.

Two readings were taken from each quadrant of the register with the doors open, and that test was repeated with the doors closed. The readings were then averaged. As mentioned above, the doors created a fairly tight seal on the room when closed. It was remarkably difficult to open the exterior door (which opens inward) when the HVAC unit was blowing air into the room due to the tight seal of the room envelope.

As the charts show, there is a significant reduction of air flow into this room when the doors are closed. The CFM's (Cubic Feet per Minute) dropped from 262 CFM with doors open to 119 CFM with doors closed.

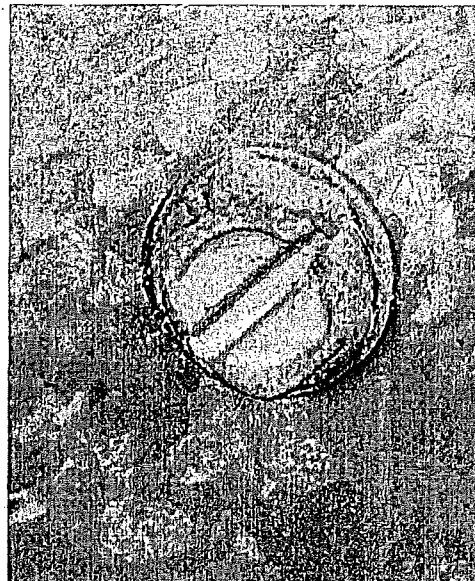
A closer inspection of the west HVAC unit on the roof found that the screws holding the panel for the controls showed no signs of having been opened for some time (Figures 29-30). The screws that held the panel cover inside unit had not been opened. One interior cover screw had 1/8 inch of dust on it. Figure 31 shows that there is a significant amount of dust on the interior wiring and components as well. This would indicate that no-one had serviced this unit in quite some time.

Figures 29-30. Mounting screws on west HVAC exterior and interior panel covers for accessing service bay area.

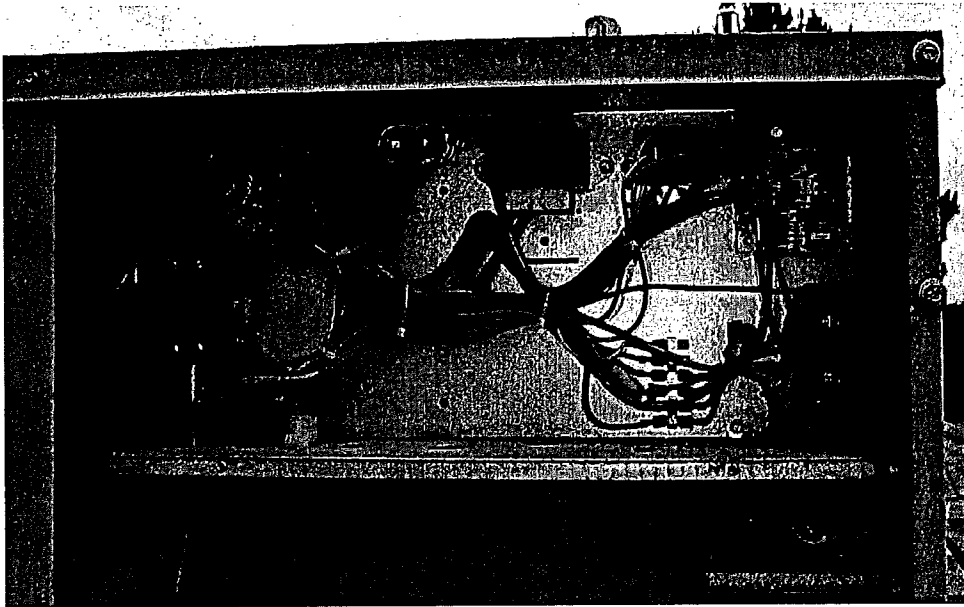
Figure 31 Service bay area inside west HVAC unit.

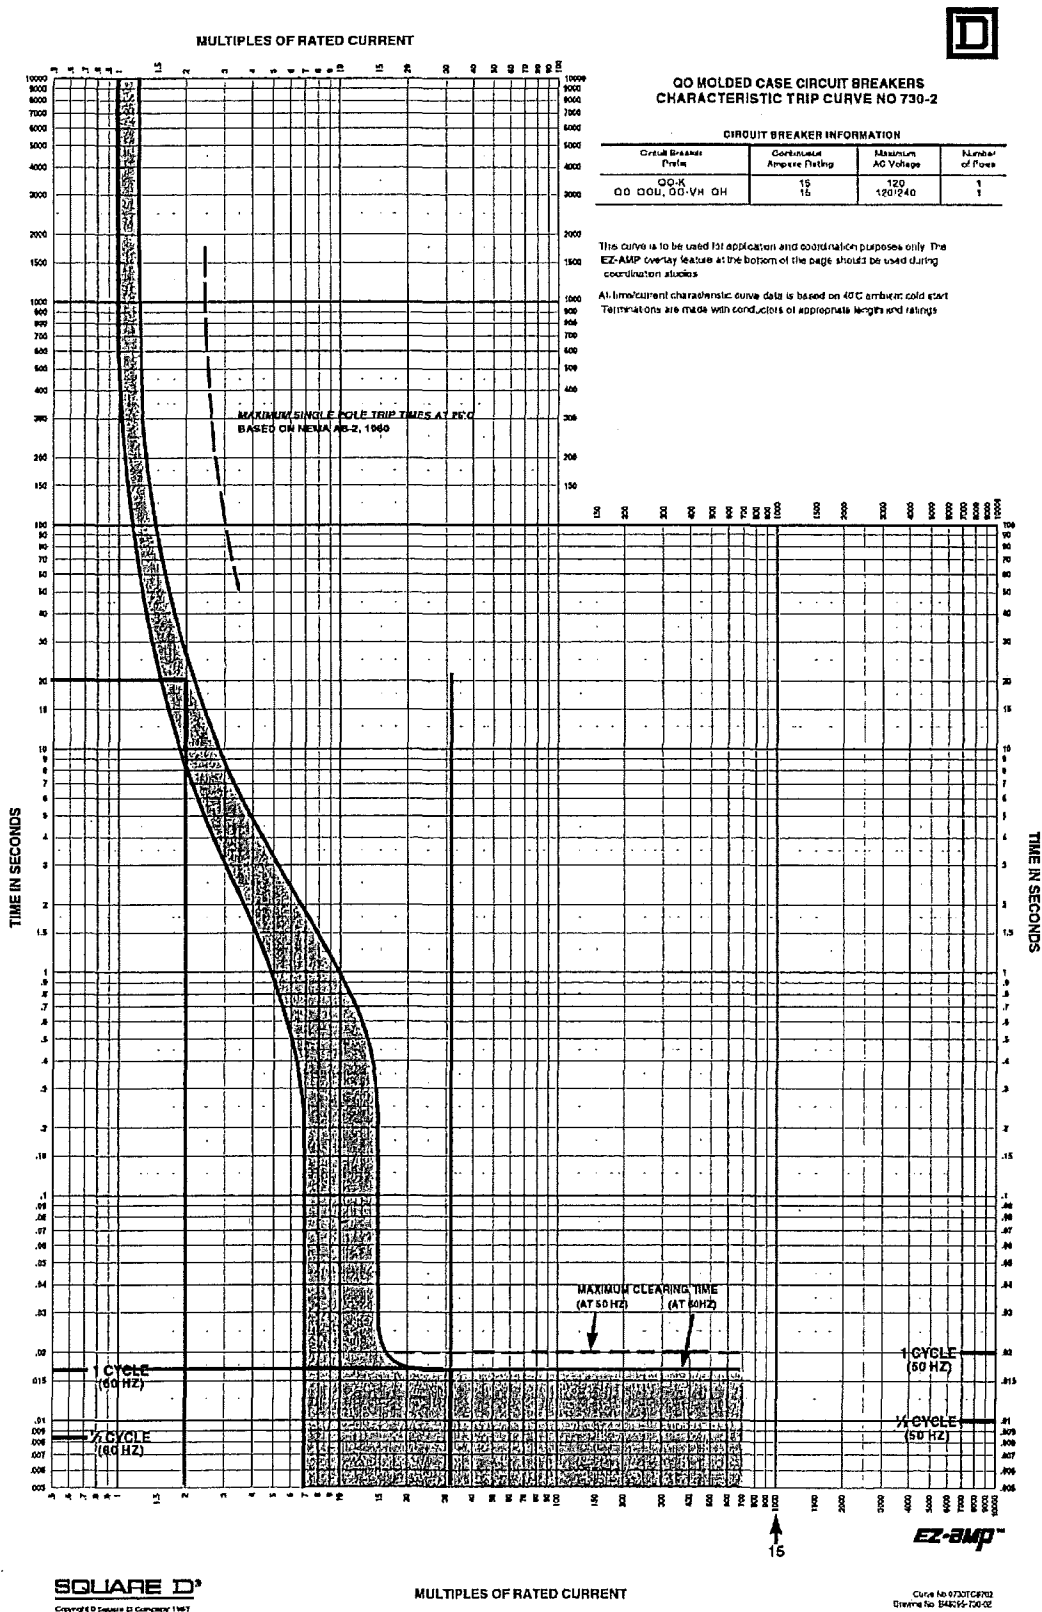
APPENDIX 1. TRIP CURVES FOR 15 AMP SQ D CIRCUIT BREAKER

Appendix 1 below shows the time-current curves for a 15 amp Square D circuit breaker. The red lines show the results of EFX testing at 200% of the rated current and we see that the circuit breaker tripping at less than 20 seconds is within the manufacturer's specified results (shaded area on chart). The green lines on the chart show that this breaker will trip within 1/60th of a second at 32 times the current or a direct short. This was shown to be functional on the 15 amp breaker, as there was not time to even start the stop watch timer before the breaker tripped for the short circuit test.

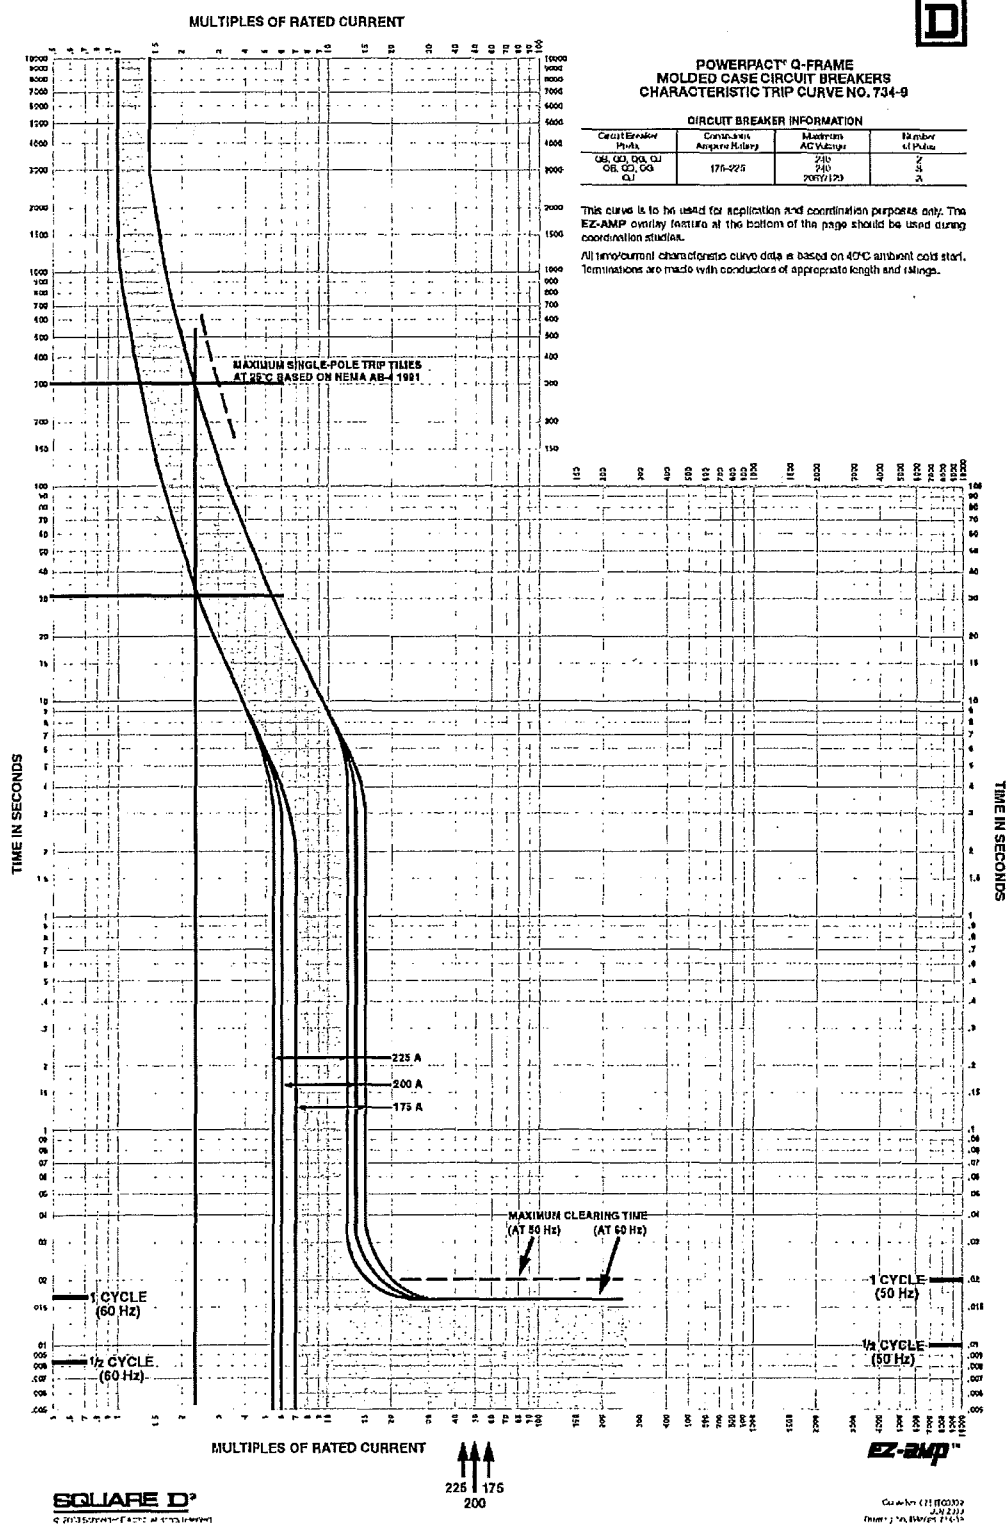
APPENDIX 2. TRIP CURVES FOR 200 AMP SQ D CIRCUIT BREAKER

Appendix 2 below shows the time-current curves for a 200 amp Square D main circuit breaker. The red lines show the maximum Isc of 2.4 times the rating and it would take from 30 to over 300 seconds for that current to trip the main. From practical experience and "real world" observations of this Journeyman Electrician of 35 years, this does not happen, and would have melted the 14/2 romex, which didn't happen. Clearly, it is impossible that this 200 amp main tripped, therefore it is clearly impossible that any dog chewing on the 14/2 in that wall caused any failure of the HVAC system.
