ENGINEERING FORENSICS EXPERTS LLC

ENGINEERING EXAMINATION and ANALYSIS
REPORT #1

File No: 4874-0701

Date of Incident: June 19, 2014
Location of Incident: 15723 E. Appleby Road, Gilbert, AZ 85298
MCSO Case: IR 14-014274

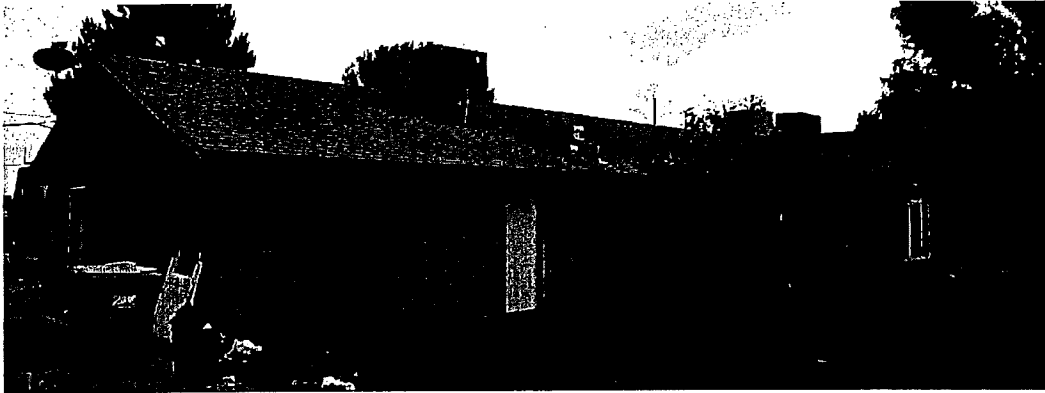
Figure 1. Rear view of house looking northeast.

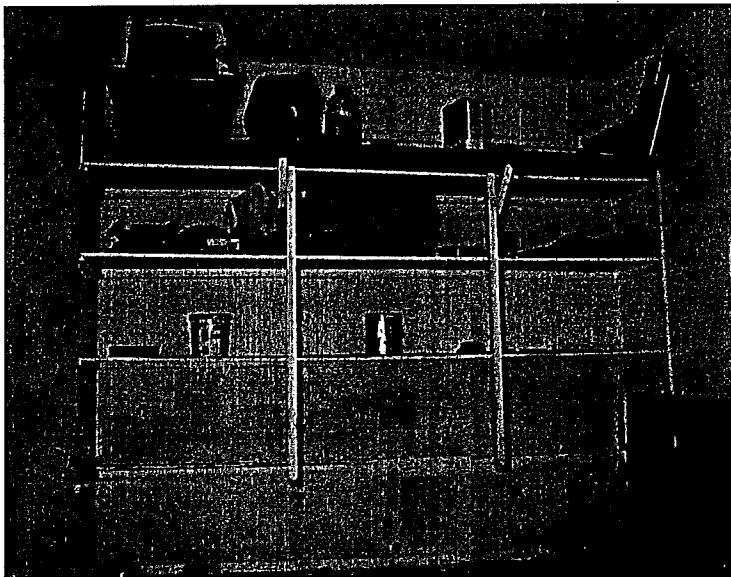
Figure 7 shows the south exterior door entering into the dog room and also shows the HVAC system that serves the west portion of the home. For purposes of this report, we will refer to this as the “west HVAC” unit. Figures 8-11 show the interior walls of the dog room, which was measured to be 9 feet by 12 feet and the ceiling was 8 feet, 3 inches from finish floor. The passage door shown in Figure 9 that led to the girl’s bedroom had been sealed completely with caulk so no air could pass through at all. The passage door into the laundry room and the exit door to the south yard shown in Figure 10 both had sweeps and weather stripping such that the room was actually fairly tightly sealed.

Figure 8. West wall of dog room.

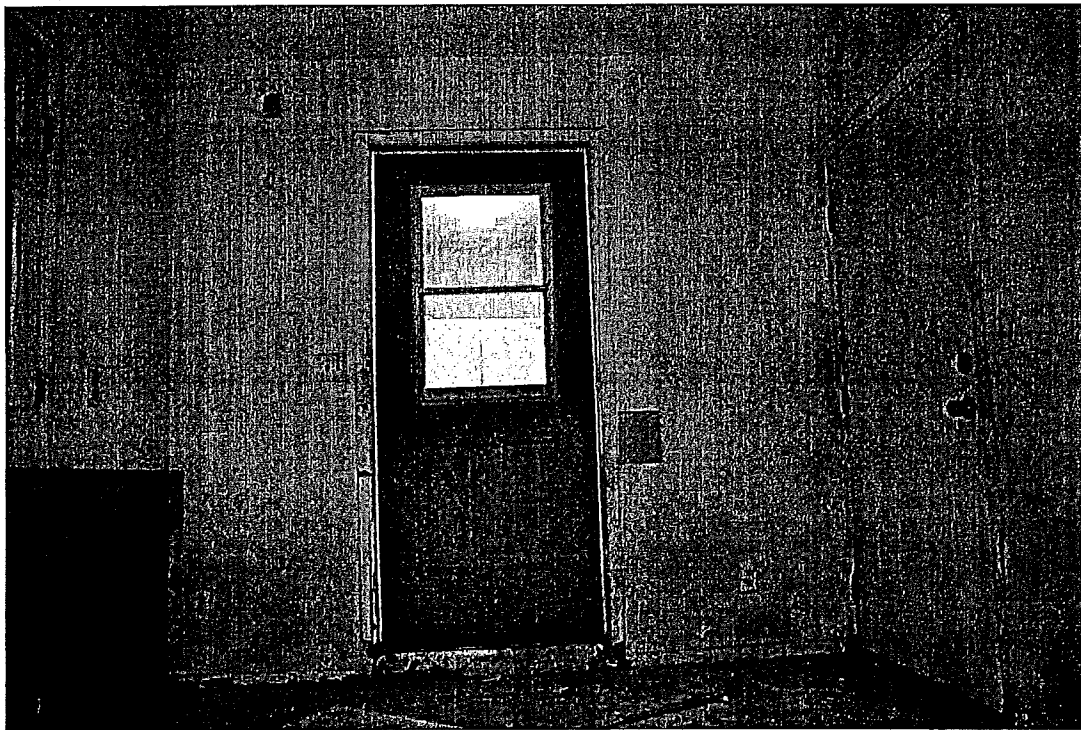
Figure 10. East end of room showing door into laundry (center) and door to south exit on right.

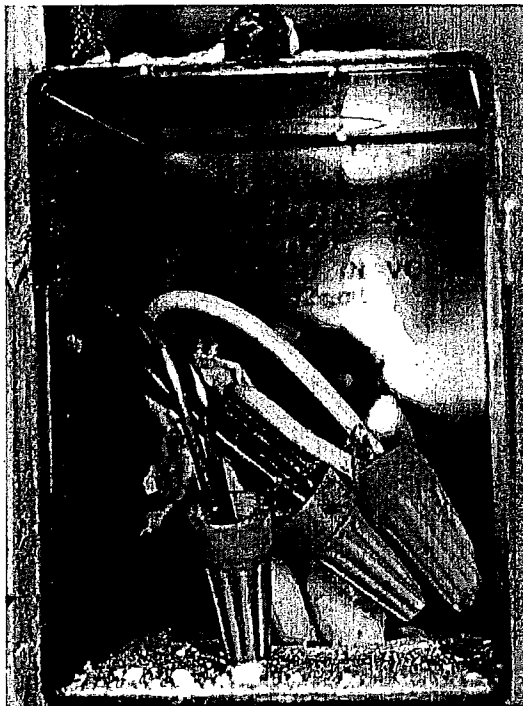
Figure 12 shows the location where the romex cable had reportedly been chewed on by a dog. It was apparent that this segment of cable had been replaced since the incident. A "new" segment of 14/2 romex had been extended from the receptacle in the wall to the east to a plastic junction box that had been installed to make a legal splice in. NEC (National Electrical Code) requires that all splices in any wiring must be accessible from the living space so this junction box was required to make such a splice. As shown in Figure 13, the splice was made using typical "wire nut" splice connectors that are suitable for the purpose.

Figure 13. Wire nuts in junction box.

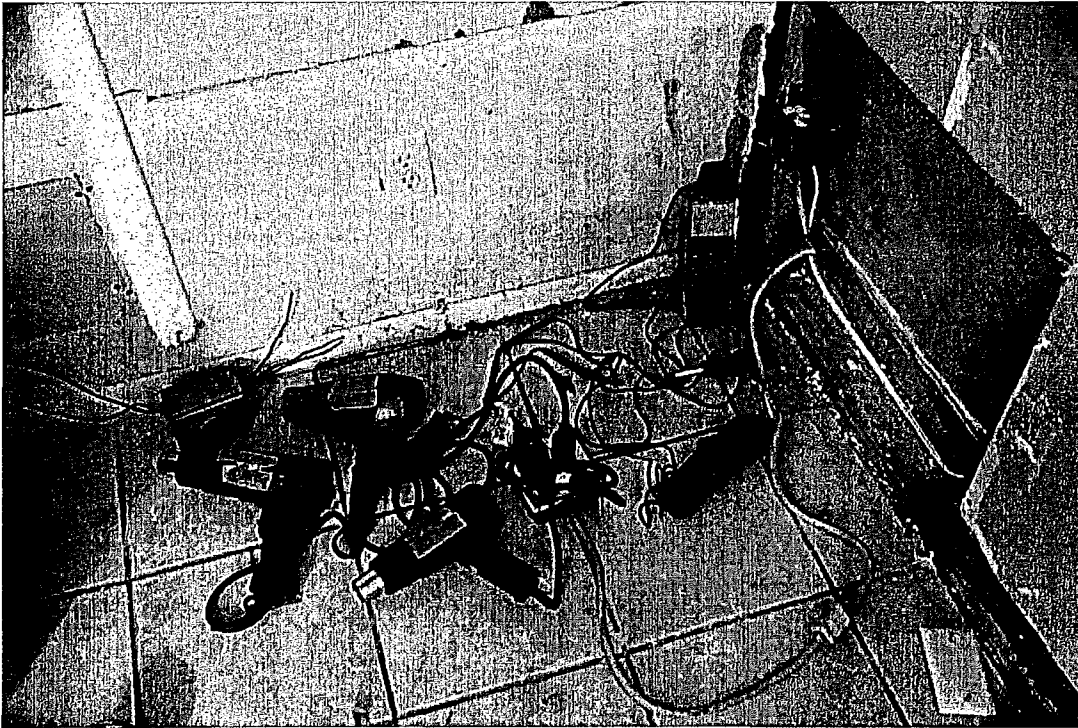
- ANSI/NEMA AB4, Article 5.5: Inverse Time Overcurrent Trip Test: This test is conducted by placing a load of 200 to 300% of the rated current on the breaker and would in this case simulate the current that could be expected if a dog chewed on the cable and caused a short circuit that traveled through the saliva and flesh of the dog's mouth. For this test, a load of about 32 amps was placed on the circuit of the 15 amp breaker as shown in Figure 17. Within less than 20 seconds, the 15 amp circuit breaker tripped (Figure 18) and the current flow ceased. The 200 amp main circuit breaker was unaffected (Figure 19) and the HVAC units continued to operate.

- ANSI/NEMA AB4, Article 5.6: Instantaneous Overcurrent Trip Test. This test is conducted by very quickly ramping the current to multiple times the rating of the breaker and would simulate the dog chewing the cable such that the energized conductor insulation was compromised and it came into direct contact with the neutral or ground, resulting in a direct fault (short circuit). For this test a heavy duty switch was connected to the hot and neutral conductors, then the circuit was energized and the switch was closed (turned on). The 15 am circuit breaker tripped instantaneously, while the 200 amp main breaker was unaffected. The HVAC units continued to operate.

Figure 17. Test equipment utilized for testing circuit breaker coordination and tripping.

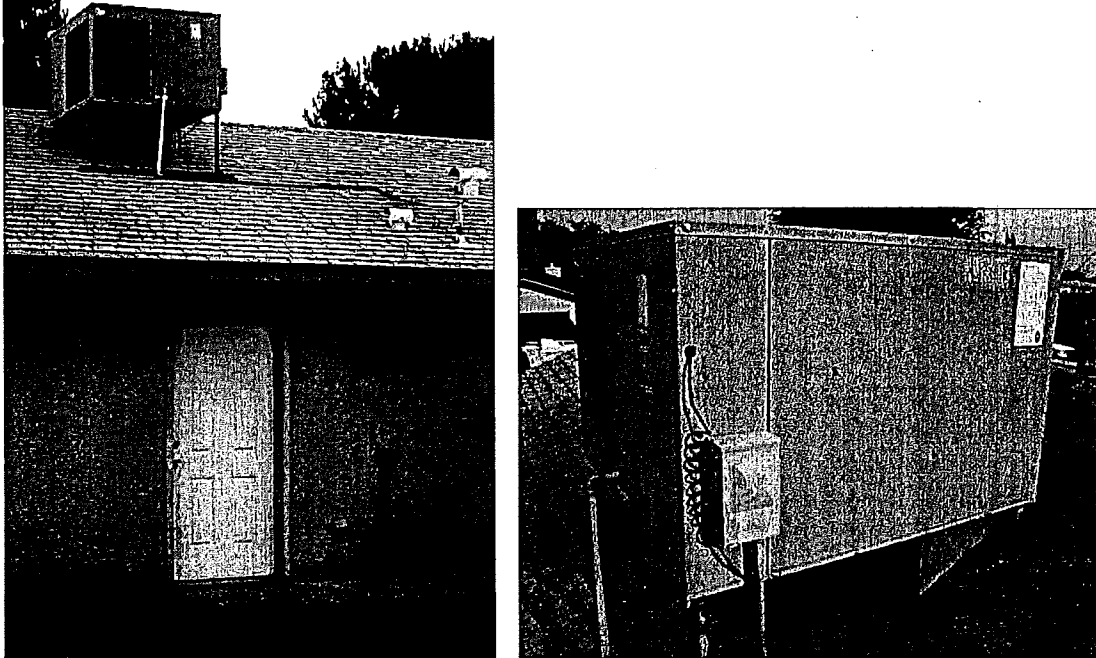
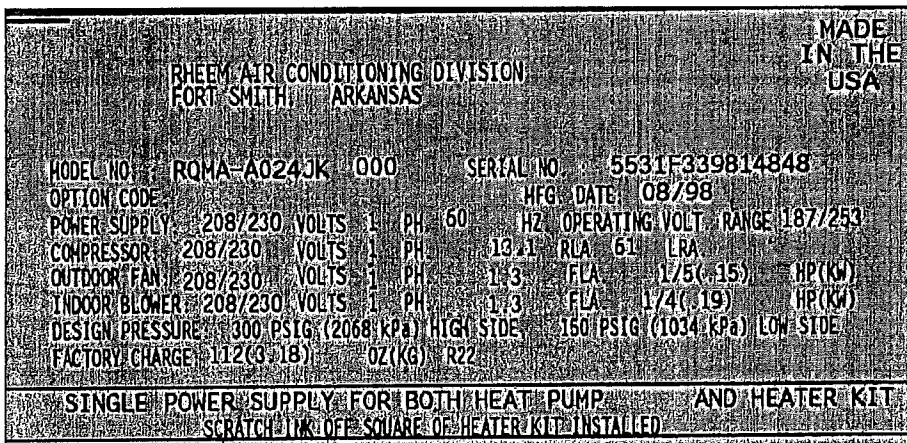
Figures 24-25. West HVAC unit on roof over west bedroom and dog room.

Figures 25-26 were taken on the roof. The west HVAC unit is a 2 ton Rheem HP model #RQMA-A024JK, serial #5531F339814848. Unit was built in the 33rd week (approximately August) of 1998. Fuses in unit disconnect were rated for 30 amps and the

A closer inspection of the west HVAC unit on the roof found that the screws holding the panel for the controls showed no signs of having been opened for some time (Figures 29-30). The screws that held the panel cover inside unit had not been opened. One interior cover screw had 1/8 inch of dust on it. Figure 31 shows that there is a significant amount of dust on the interior wiring and components as well. This would indicate that no-one had serviced this unit in quite some time.
